LOSS CONTROL BULLETIN

MFG: MANCO PRODUCTS, INC.
 NAME: ROUND UP - *FOLD*
 TYPE: NON-KIDDIE

EMERGENCY ALERT ON THE RIDE, "ROUND-UP"
 (by Manco, Hrubutz Mfg, or Kilinski Mfg)

In early June 1993, a Round-Up ride experienced a failure of a weld located on the shrink collar on the main center spindle (two drawings are attached for reference). This is the first known occasion for this style of shaft to fail since the manufacturer's Bulletin requiring replacement of an earlier system.

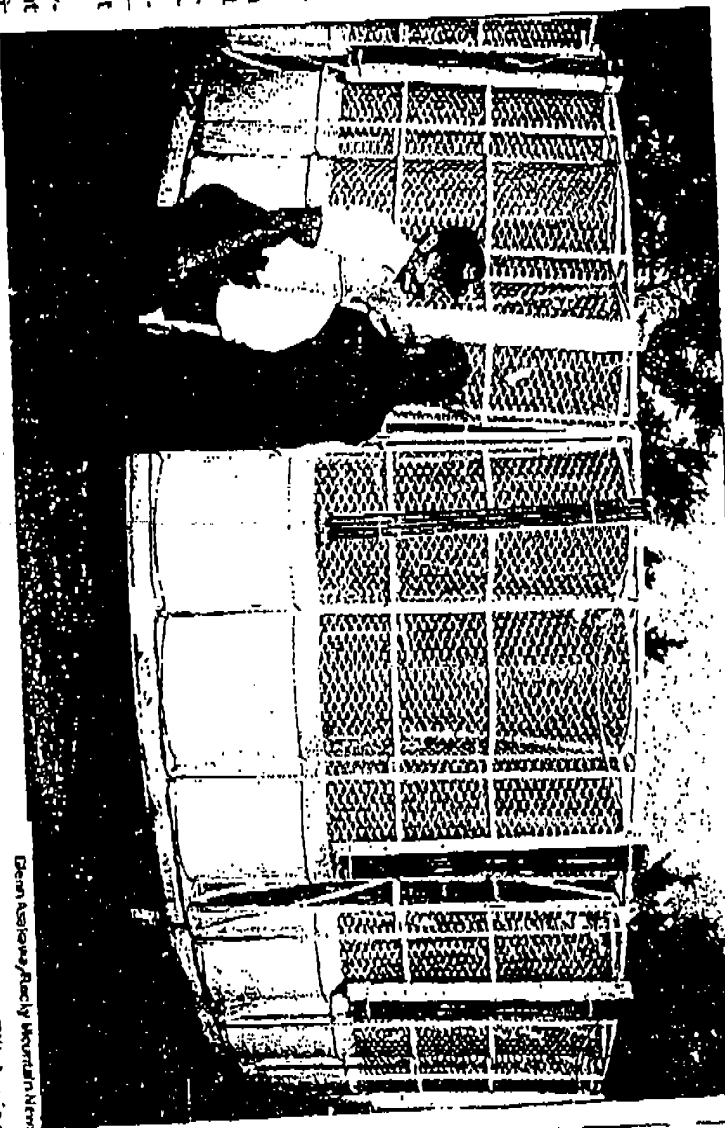
Don Meineke, left, assistant ride foreman for Elitch Gardens, talks to Lori Lyons, Elitch vice president of administration, as he inspects the Round Up ride after it stranded riders.

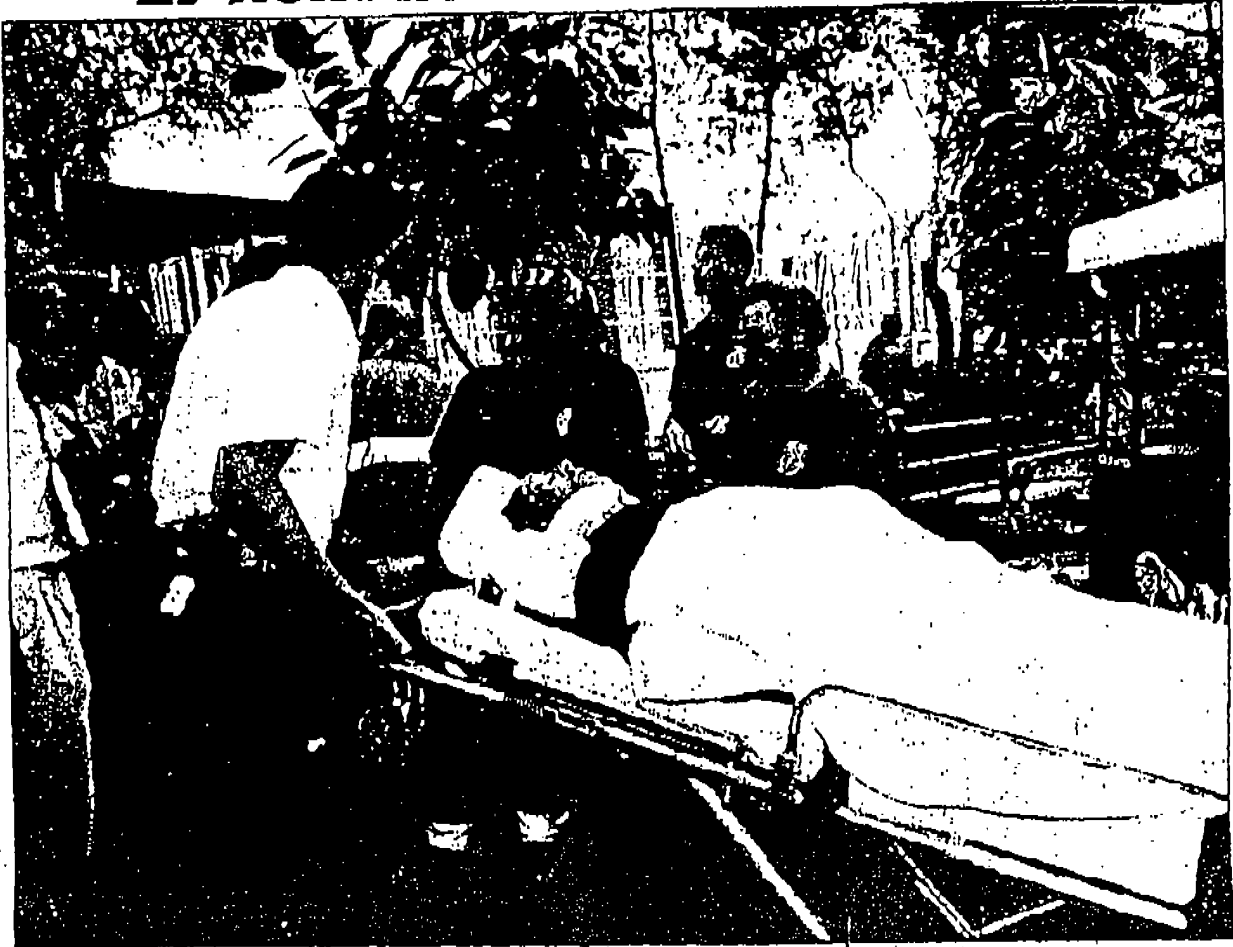
An injured man is wheeled off after an accident on the Round-up ride at Elitch Gardens.

Strut on Round-up comes loose

Danver firefighters were dispatched at 7:48 p.m. to rescue 30 stranded passengers on the Round-up ride after one of 16 horizontal metal struts came loose, park officials said. The spinning, tilting ride stopped abruptly.

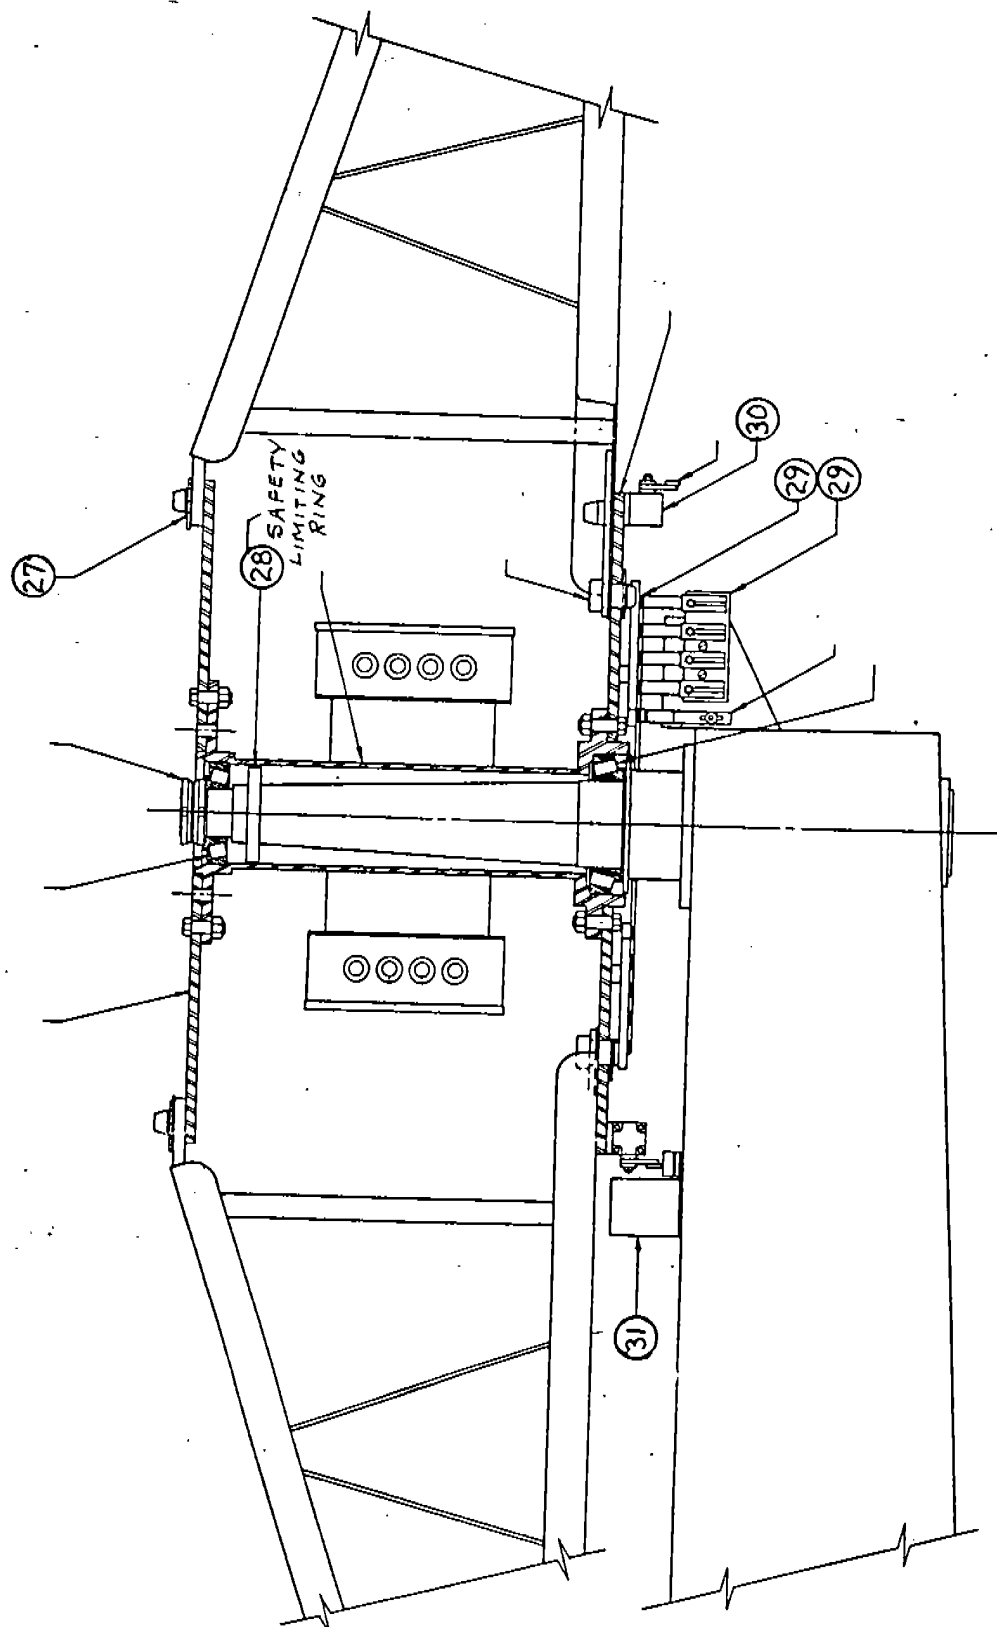
MAN-CO MFG. INC. 8170 JFWALD AVE. S.E. SALEM, OREGON 97302	
DESIGNED BY: PETE T.	DATE: 8-26-80
CHECKED BY: [Signature]	DATE: [Blank]
CENTER HUB ASSEMBLY	
REVISED AND REDRAWN	FR-503 S C

A Round-Up manufactured by Frank Hrubetz & Co., Inc. has experienced a failure in the upper bearing in place on the main spindle. When this happened, support at the top of the spindle was lost making it possible for the rotating platform to tilt and contact the main boom.

This condition makes it possible for the pins and sweeps to hit the boom and bring the rotating platform to a sudden stop.

1. Remove the center ornament and inspect the weld on the hub (shown in drawings RD-35R and FR-503S) for cracks. If there are cracks, ship the hub to Man-Co Mfg.. We will repair, using the design presently being used.
2. Remove the top bearing and visually inspect the bearing and make sure there is a safety limiting ring in place. If there is a limiting ring on your ride, it will be plainly visible on the upper portion of your main spindle shaft. If it is not present, we highly recommend that you add this part immediately. (Part #STD 353)

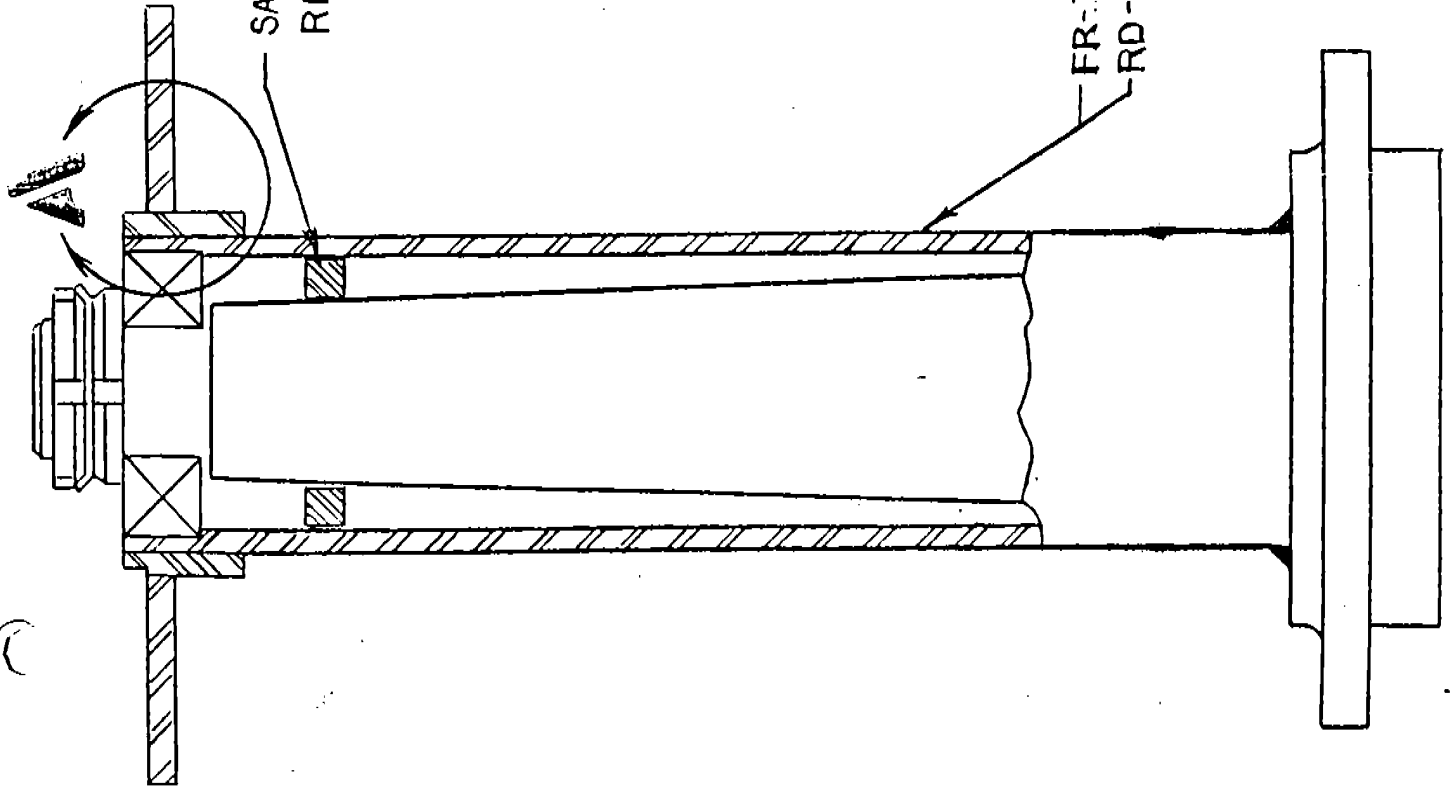
DETAIL

The main spindle shaft hub housing on the Round-Up and Paratrooper amusement rides that were manufactured by Frank Hrubetz Co., and Kilinski Mfg. Co. (KMC) have shown some sign of fatigue cracks in the weld areas of the hub assemblies.

IF CRACK IS
NOTED IN THIS
AREA, CENTER HUB
SHOULD BE REPLACED

We at Man-Co feel that this is something that should be inspected on a more regular basis and so we are recommending that the welds shown in the attached drawing (BU-136-MC) be inspected annually. If any sign of stress or cracks are noted, then we recommend that the entire hub assembly be replaced for the safety of the ride owners and customers.

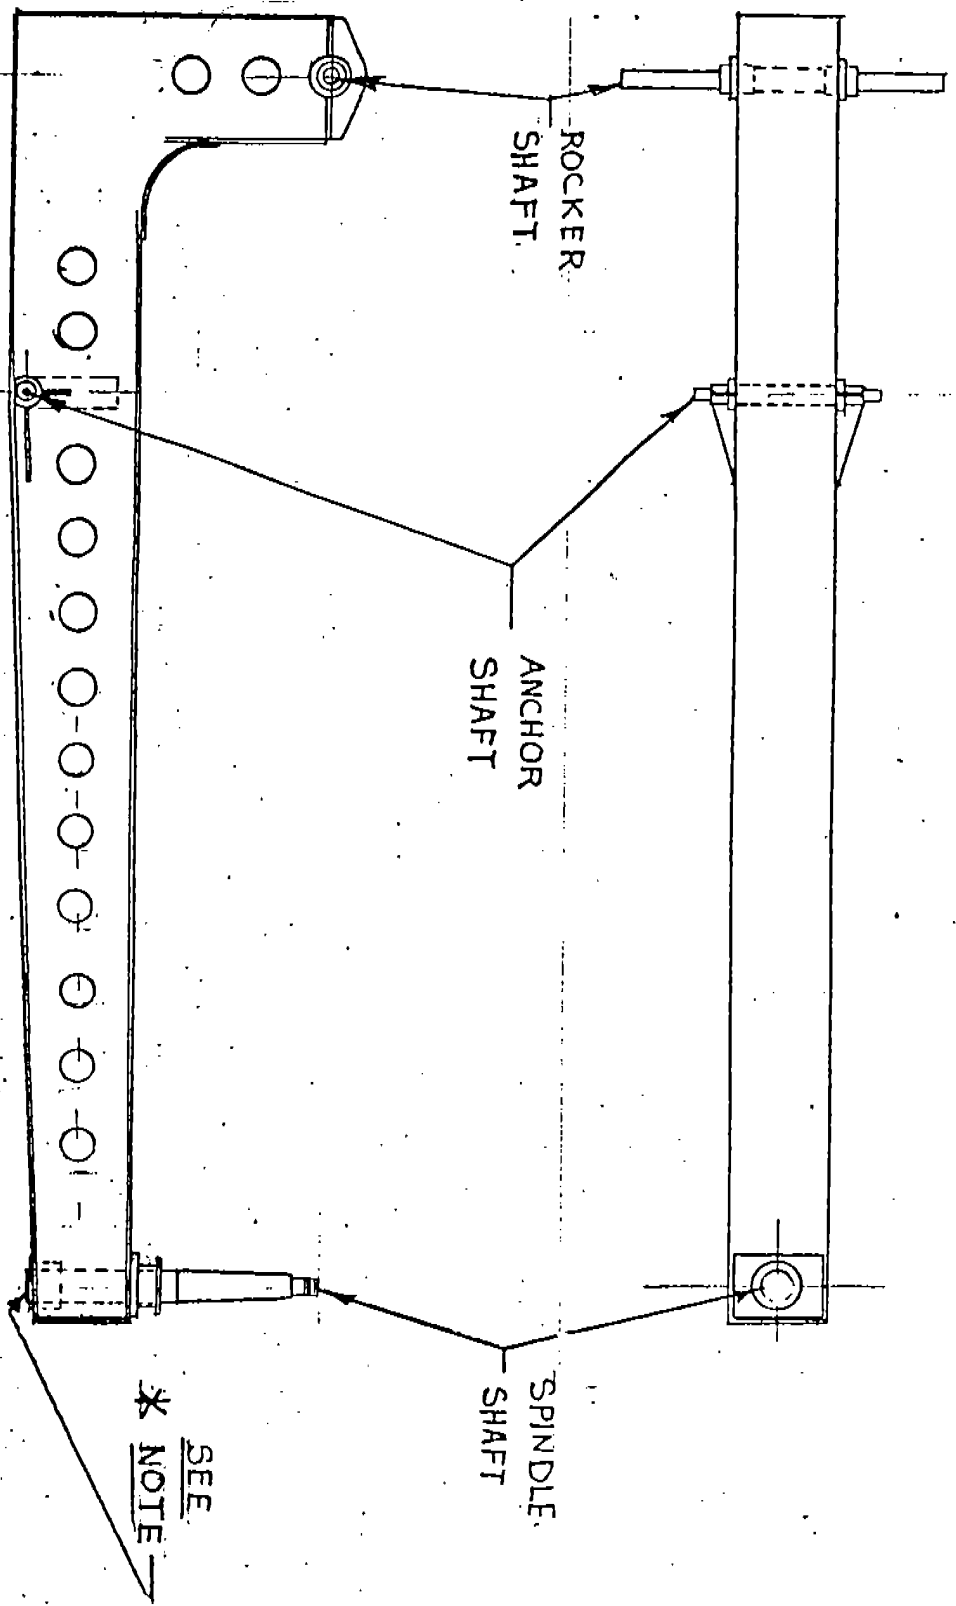
BU 138-A

It has been brought to our attention that there have been recent failures of the shafts and spindles of the above mentioned rides that were manufactured by Frank Hrubetz Co. and Kilinski Manufacturing Company (KMC). For various reasons, these failures have only occurred in those rides that have the shafts and spindles welded directly into the boom. Newer rides and replacement shafts and spindles that have used shrink collars for installation (therefore no direct welding to the shaft) have not experienced these failures and with proper maintenance and regular testing should provide years of safe operation.

*NOTE: IF NO SHRINK COLLAR IS VISIBLE AT BOTTOM OF BOOM, THEN REPLACEMENT OF SPINDLE SHAFT IS NEEDED.

- 1) Inspect your ride and determine if the shafts and/or spindles are welded in directly, or if shrink collars are used. (See Drawings BU-138-A through F for information on how to determine the installation method used on your ride.)
- 2) If shrink collars are used on your ride, there is no need for replacement. Please note: All shafts and spindles still need to be tested annually according to the procedures outlined in BU-135-MC (QC-UI-1 - Rev. 3).
- 3) If the shafts and/or spindles on your ride are welded directly to the boom, then replacement is needed.

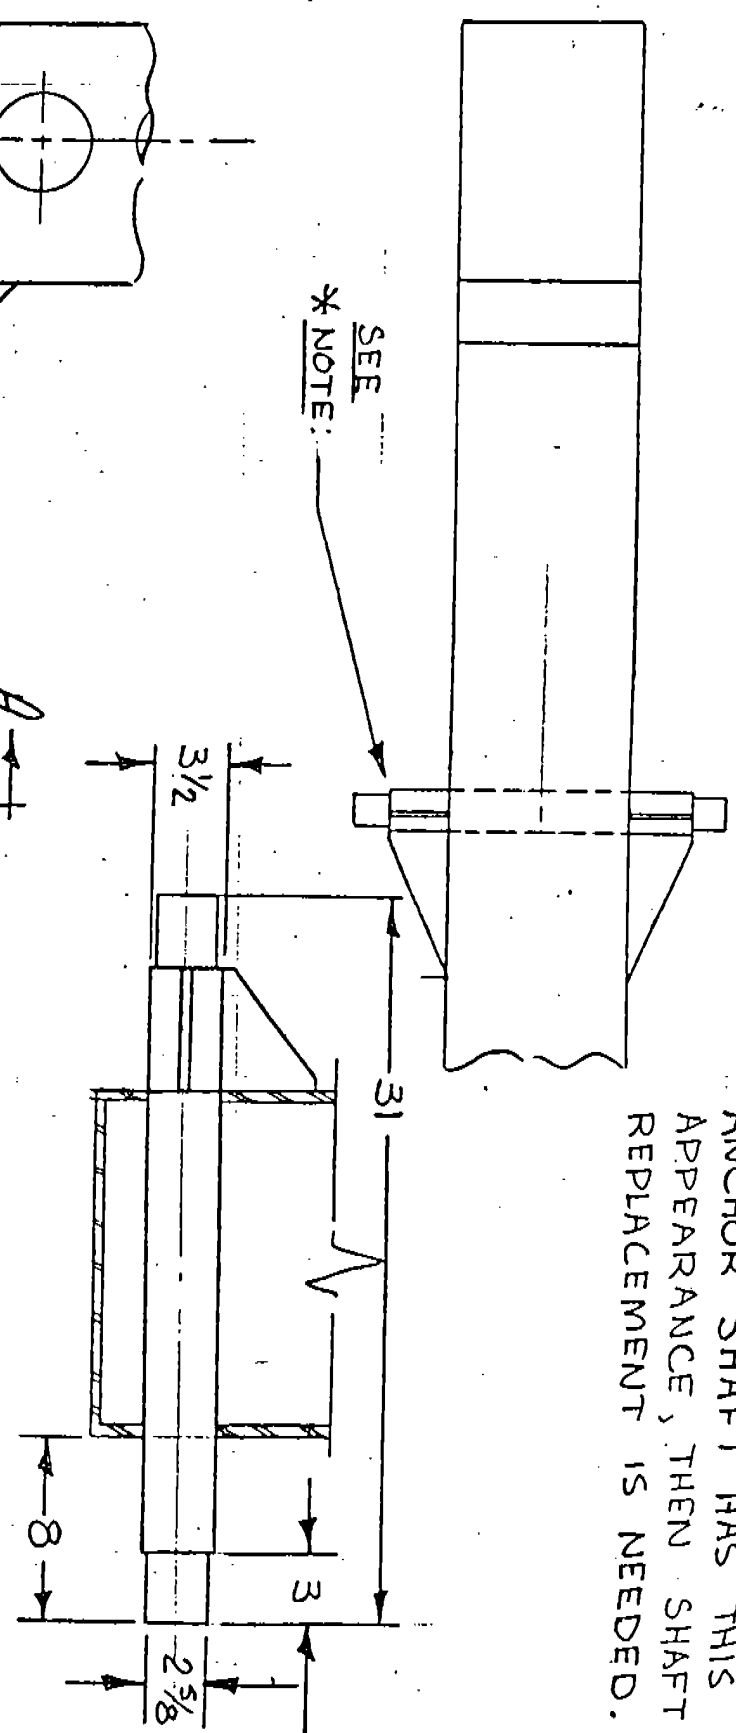
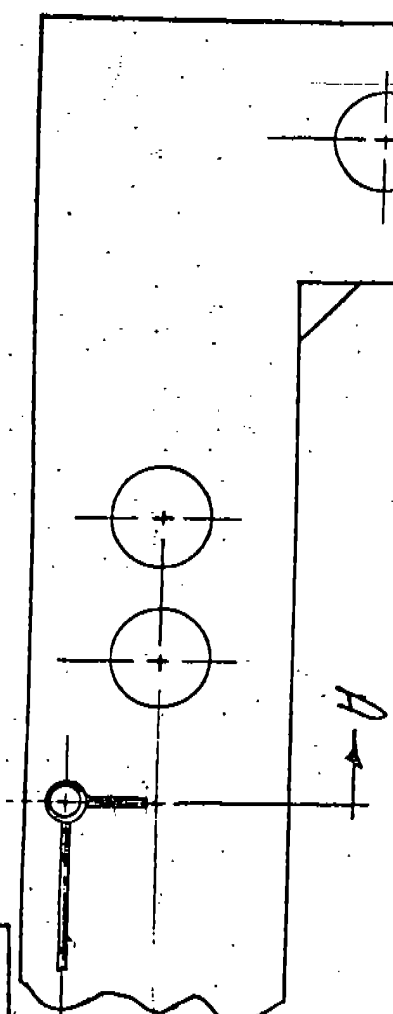
VIEW A-A

* NOTE: IF CYLINDER ANCHOR SHAFT HAS THIS APPEARANCE, THEN SHAFT REPLACEMENT IS NEEDED.

SHAFT SHOWN PRIOR TO SHRINK COLLAR

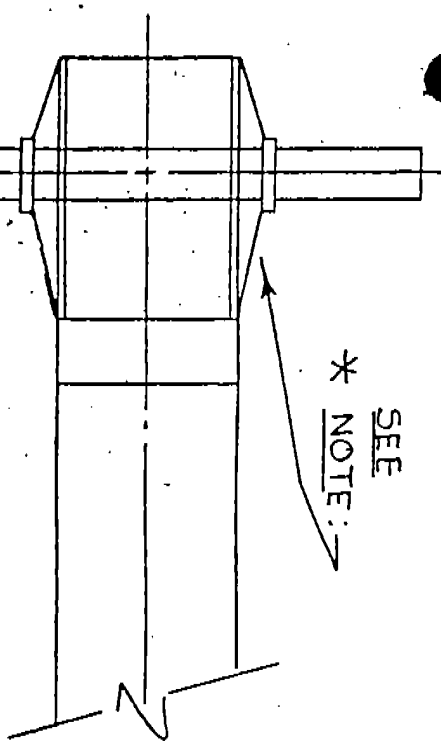
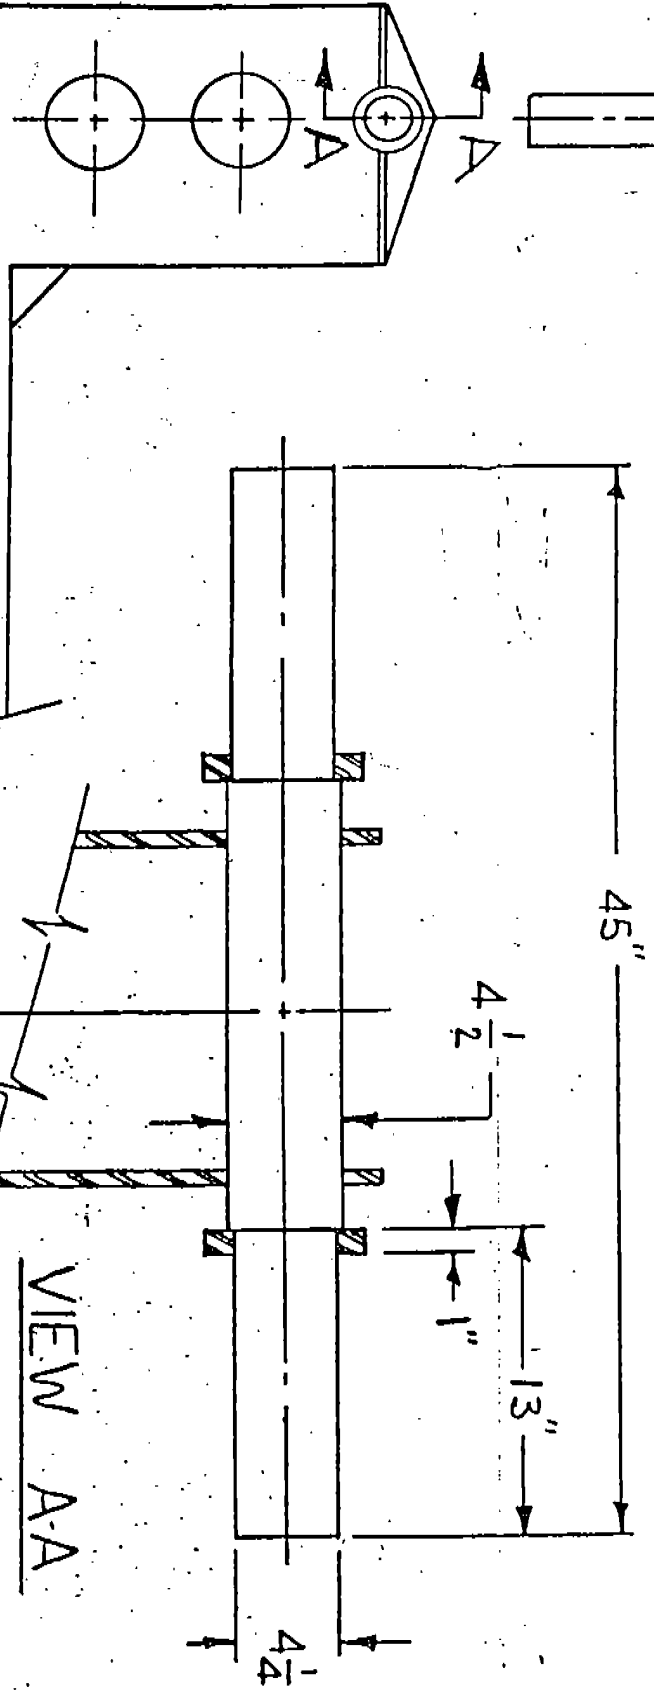
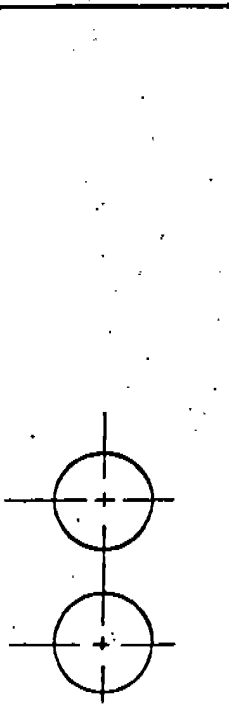
VIEW A-A

* NOTE: IF ROCKER
SHAFT HAS THIS APPEARANCE
THEN REPLACEMENT OF SHAFT
IS NEEDED.

SHAFT DIM. SHOWN PREVIOUS TO SHRINK COLLAR
