STANDARD & DELUXE SCRAMBLER®

INSTRUCTIONS
FOR
ERECTING
OPERATING
SERVICING
THE

Big Eli Scrambler

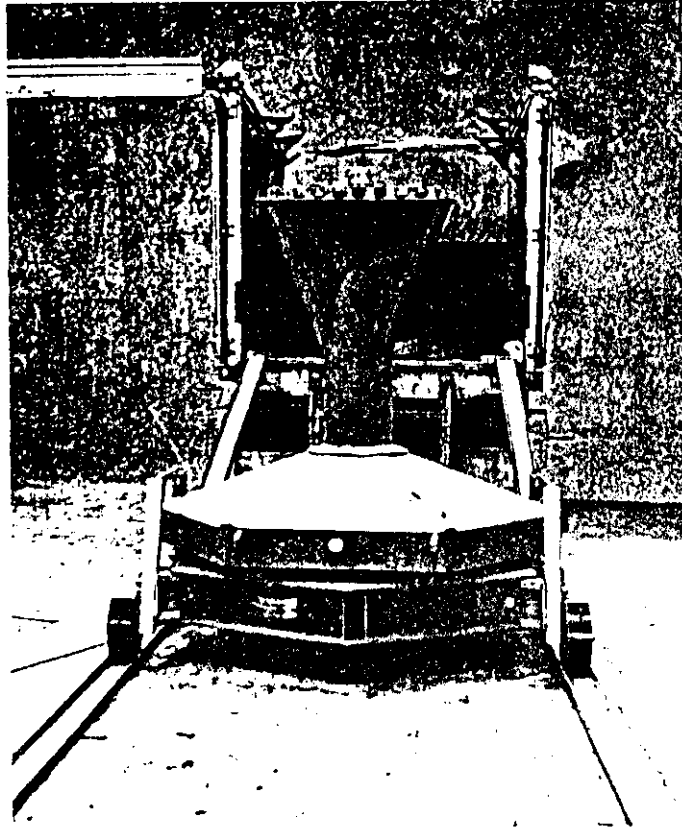
No. B-3

When the base section reaches the bottom of the ramps, all four wheels stand on the runway channels. See Picture No. B-3. Next, drop the wheels so that the base will lower to the ground. To do this remove the bars which connect the tops of the dollies. Next, insert the two 10 ft. long sections of pipe in the dolly sockets on one side of the base. Two men on each pipe pull the upper ends outward and downward. See Picture No. B-4.

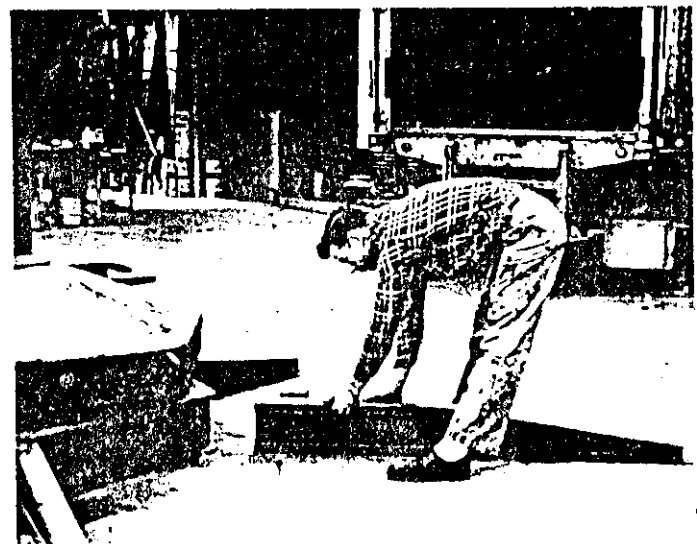
No. B-6

pinch your fingers with the dollies. After the dollies are out, put the legs in and pin them in place. See Picture No. B-6. The six pins that hold the legs in the base are longer than the rest of the assembly pins. This size of pin is used in no other place in the SCRAMBLER.

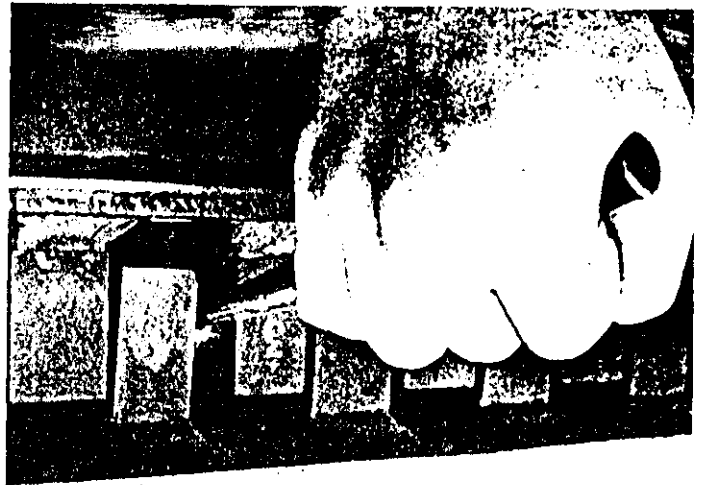
No. B-8

Next, attach the mast, which is the top part of the center pole. Set the ramps to one side and then back the van against the base section. The mast is on its side in the van. Scoot it to the rear of the van with the bottom of the mast next to the base section. Always locate the mast in the same position on the rotating base. Match

up the "3" stamped on one hinge block on the mast with the "3" stamped on a similar hinge block on the rotating base. See Picture No. B-8.

1. Check piano hinge for looseness, no cracks around hinge blocks.
2. Each long pin secured by hairpin cotter.
3. Rotating base and mast matched with "3" on hinge blocks.
4. Serial number location.
5. Bottom sweep pin holes worn.

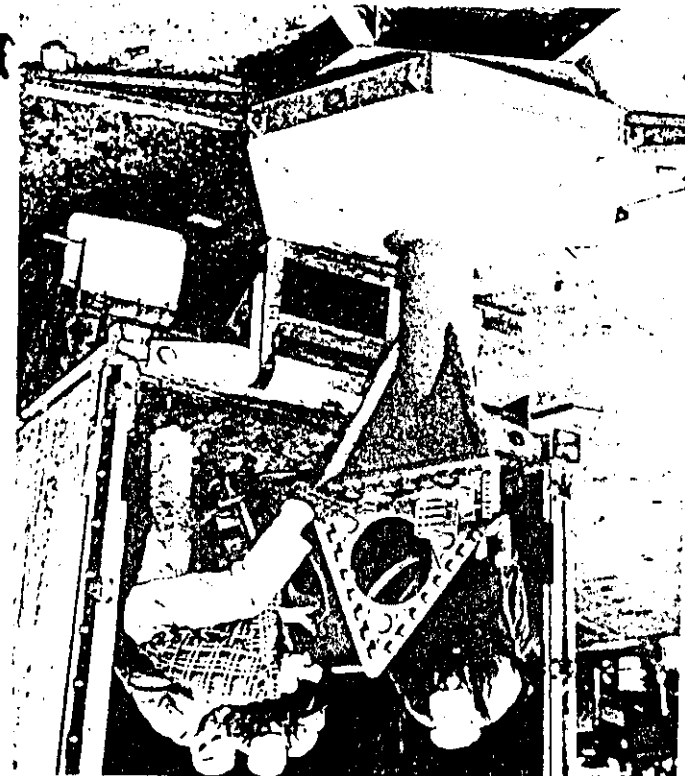
No. B-9

Four men then lift the mast into place. Raise it horizontally and set the bottom of the mast on top of the center pole base section. See Picture No. B-9.

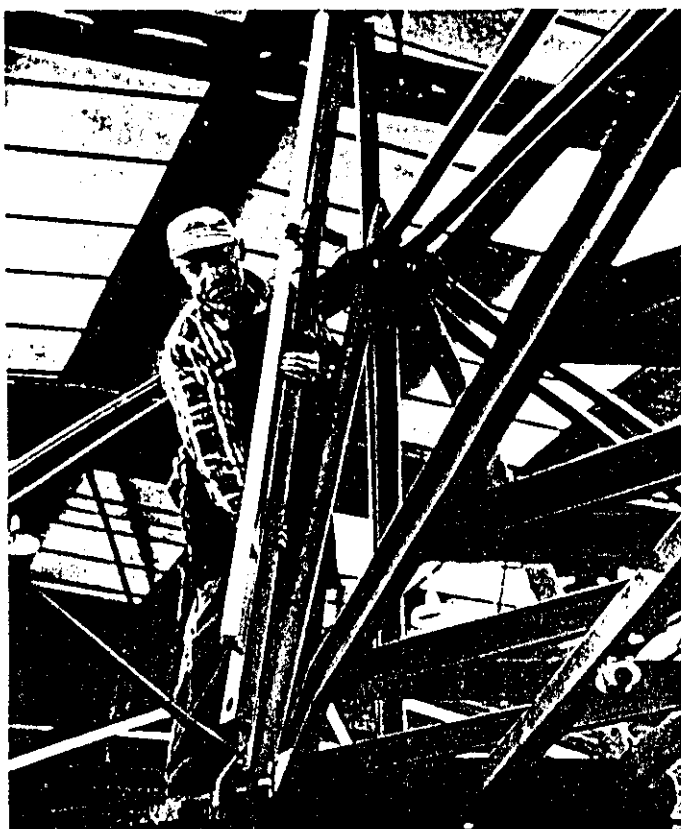
No. C-9

The mast light panels are the three short ones which are fastened to the mast. See Picture No. C-9. Down from the top of the mast panel is a bent plate and rod on the back of the strip. Insert this rod in a hole in the $\frac{1}{2}$ " thick plate at the top of the mast. See Picture No. C-10. After it is started in the hole, guide the slotted plate on the other end of the panel in behind the hook and cross-

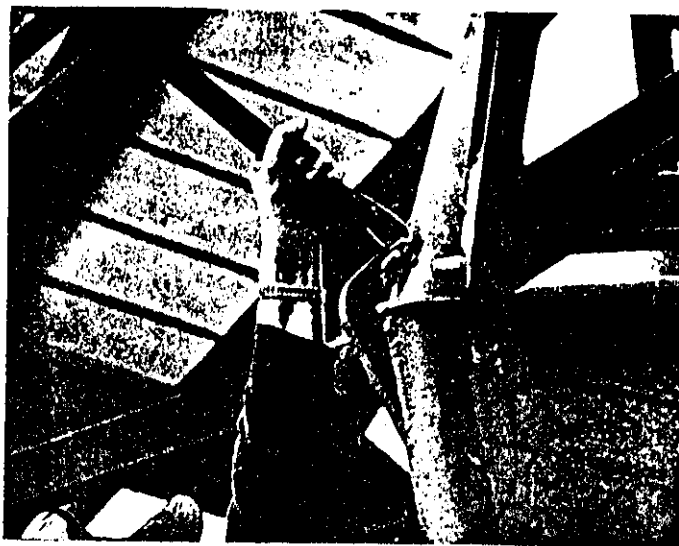
No. C-8

When the gable has reached this position, the hook is in line with a short crosspin in the corner of the mast. See Picture No. C-8. Drop this hook over the crosspin and the gable lights will hold their position by their own weight. This completes the installation of the gable lights.

If you have the Deluxe Model SCRAMBLER, you are provided with a locking plate which is to be inserted behind the hook of the gable light tie rod, as shown in Picture No. C-8.5. On a Standard Model SCRAMBLER the mast light panel serves to lock the hook of the gable light tie rod.

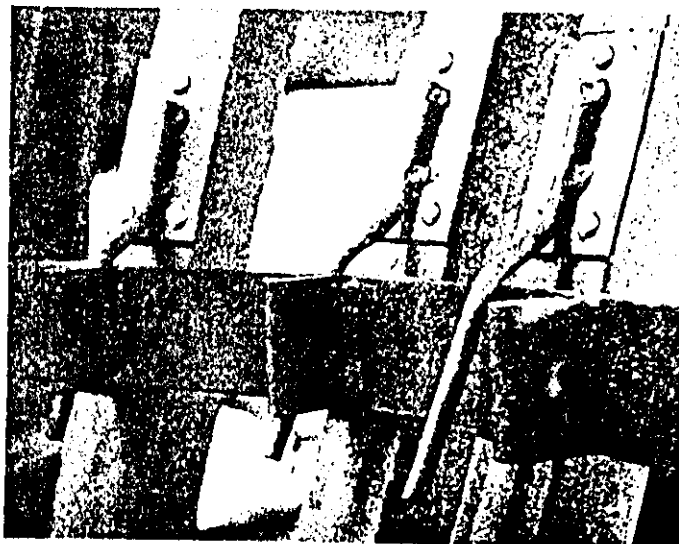
No. C-20

is a plate with a bent rod welded to it. Slide the rod down through the rectangular eye on the inner side of the large top ring, as shown in Picture Nos. C-18 and C-20.

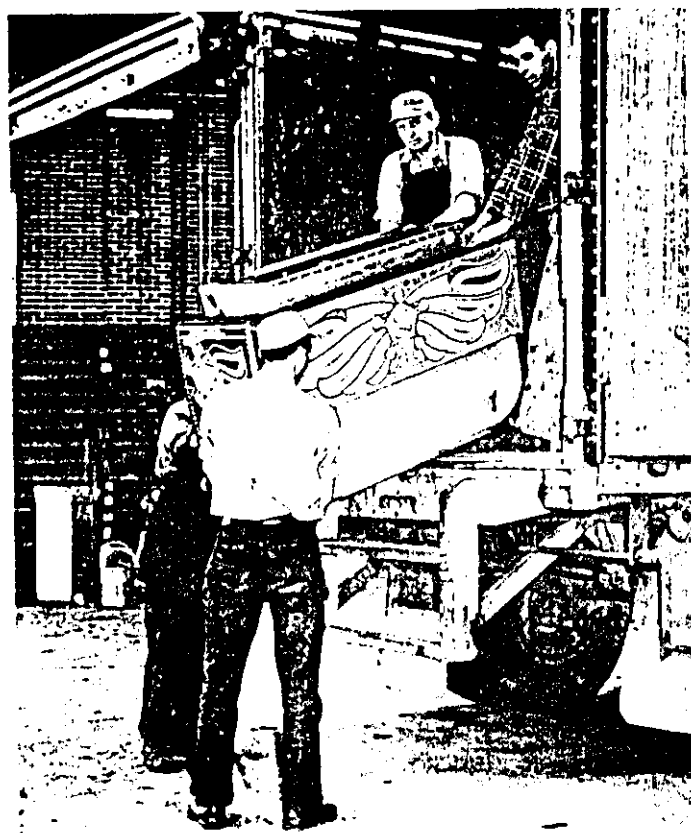
No. D-5

One man can handle a seat if necessary, but it is much easier to guide it into its pin connections if two men hold it. See Picture No. D-5. You cannot install the

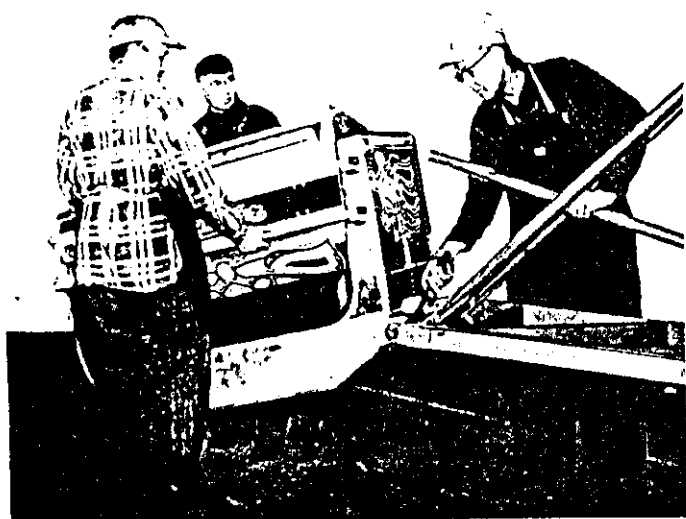
No. D-6

seat incorrectly. Drive in the two bottom pins first with the outer end of the seat lowered. See Picture No. D-6. Then raise the seat until the third pin connection lines

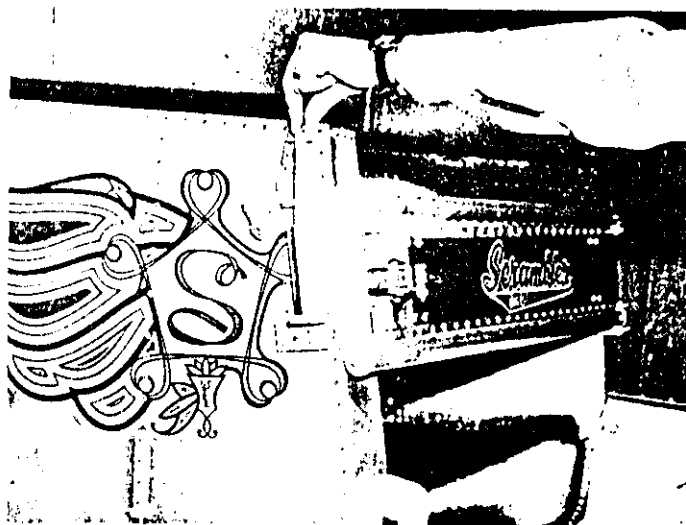
No. D-11

lip on the footbottom over the lip of the seat cushion. Lower the lap bar, close the handlebar, insert the locking pin, and hang the step over the end of the footbottom. See Picture No. D-11. Finally, lock the step to the footbottom and the footbottom to the seat with the three Airloc fasteners, as shown in Picture No. D-12. These quarter-turn fasteners can be locked with the special tool provided, a large screw driver, or a coin. All three of these Airlocs must be fastened. If all three are not locked, expensive damage to the seat can occur. Finally re-check to be sure that the footbottom is holding down the cushion. This completes the assembly of the seat to the SCRAMBLER.

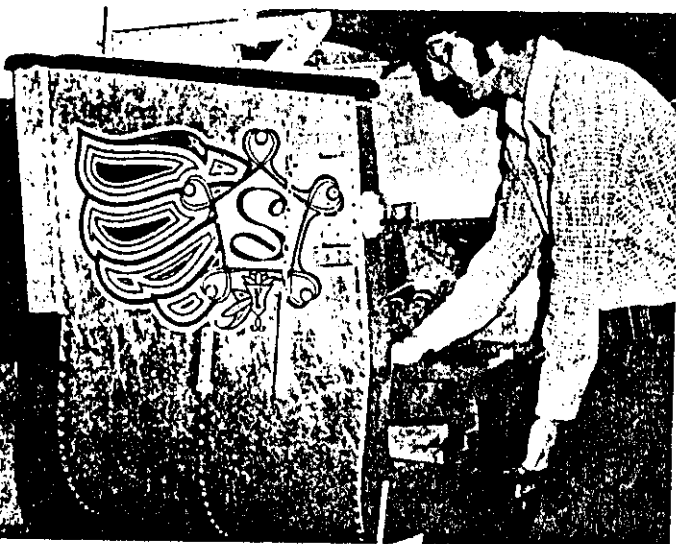
No. D-9

Open the seat handlebar as shown in Picture No. D-8. Pull the seat cushion forward to remove the pressure on the footbottom, as shown in Picture No. D-9. Fold up the lap bar and then swing the footbottom forward and up out of the way so that the seat cushion can be returned to its original position. See Picture No. D-10. Lower the footbottom to operating position, with the rear

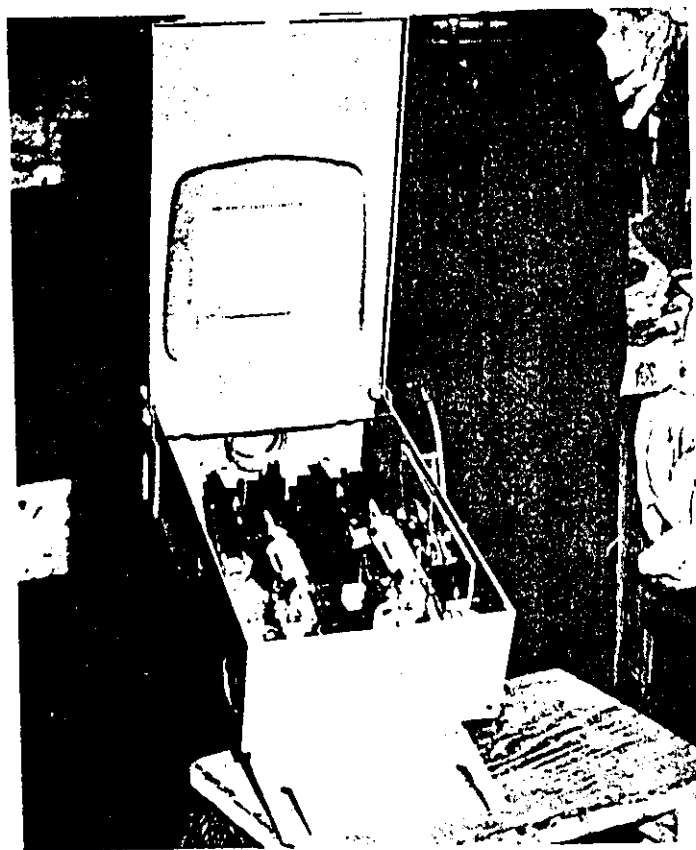
No. F-4

With the incoming "split 220 volt" power carried in three-conductor cable into the switch box, the 33-foot drop should be connected at the switch box, black to black, white to white, green (incoming) to red (33-foot drop), and the green conductor in the 33-foot drop should be connected to a "made" ground as described in the National Electrical Code. (See the special section on "Grounding".) WITH INCOMING "SPLIT 220 VOLT" POWER IN A THREE-CONDUCTOR CABLE DO NOT CONNECT THE GREEN CONDUCTOR OF THE INCOMING CABLE TO THE GREEN CONDUCTOR OF THE 33-FOOT DROP.

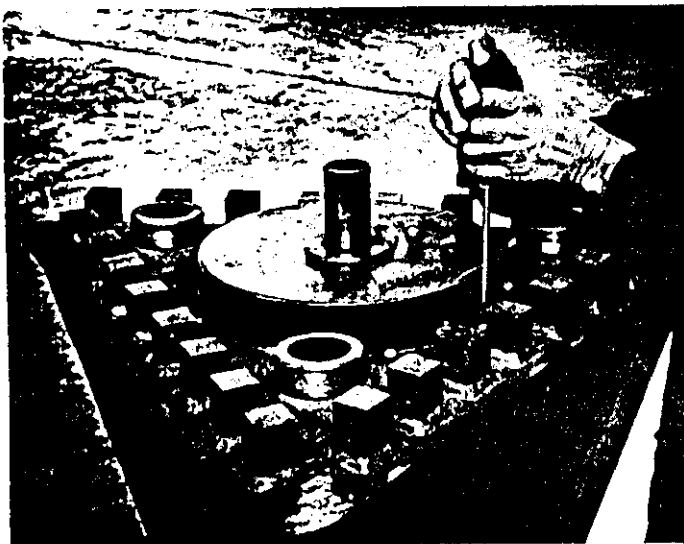
No. I-1

The center pole rides on Timken tapered roller bearings at the top and bottom of the rotating base. Also, another large Timken bearing carries a heavy gear inside

the base. These three bearings are hand-packed with grease at the BIG ELI factory, but it is important that grit be kept out of the bearings, and so you should add clean grease once a week. As you pump new grease into the bearing the old grease will be forced out, taking with it much of the grit which may have seeped into the bearing enclosure.

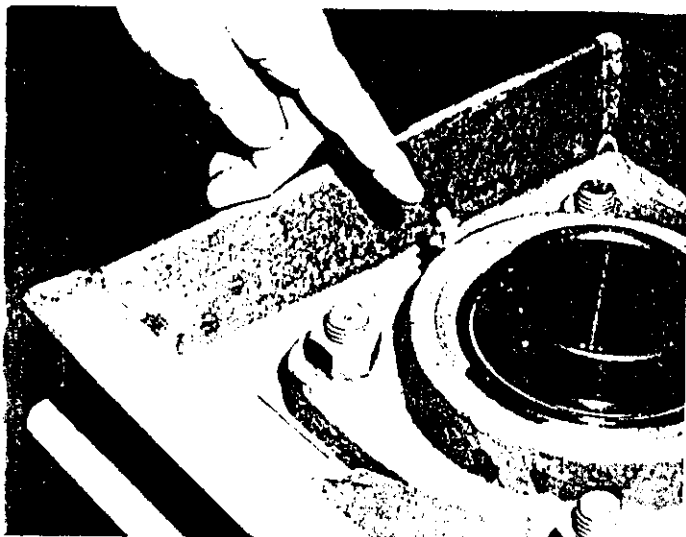
No. 1-12

A self-aligning ball bearing flanged pillow block is mounted on the outer end of each main sweep. See Picture No. 1-12. The grease fittings on these bearings have a pressure relieving characteristic, so you cannot over-grease them. Greasing should be done at least once a year.

Beneath the grease fitting a small, loosely fitting pin extends through the hole in the casting into a hole in the spherical outer race of the bearing. This pin keeps both holes in alignment so grease can be pumped into the inner race of the bearing where it is needed. Occasionally this pin is sheared off when the unit pole is swung too far away from, or toward, the center pole

there is no limit in side-to-side swing). With the pin sheared the outer race can then rotate in the casting and grease will not reach the bearing. Replace the pin if it becomes broken.

Recently, owners of a TMS, in replacing these bearings, discovered the spherical outer races of two bearings to be badly cracked, yet still together. They sent them to us. It was the first time we were able to see bearings in this condition, and we felt sure that they would give us valuable information about what was happening. We sent the bearings on to the Sealmaster Bearing Company for their analysis.

We want to emphasize that each of the four failed or about to fail bearings on the TMS Scramblers were not replaced according to our original recommendations of 3,000 hours or four years, whichever came first. These four bearings had been used five and six seasons. Had they been replaced when they were supposed to have been, then failure might never have occurred.

We have been working closely with the Sealmaster people, and we expect to have a modification available in the near future, at which time you will be informed. For the present we feel that it is imperative that these bearings be replaced regularly. On ground-model Scramblers replacement after 3,000 hours or four years, whichever comes first, still seems to be a proper replacement schedule. However, indications are that this is not conservative enough for the TMS Scrambler, and so at this time we are establishing a new replacement schedule:

The TMS Scrambler top sweep Sealmaster SF-47 ball bearing flange units must be replaced every ~~3,000 hours~~ years, whichever comes first.

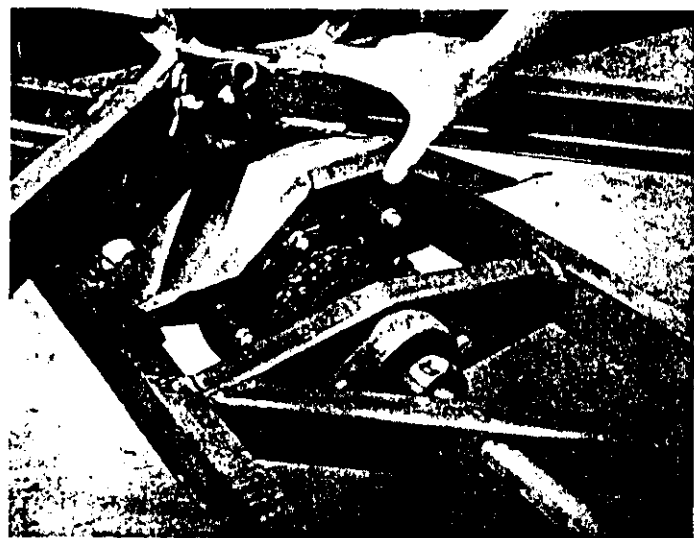
No. M-1

2. Remove the slip clutch cover as shown in Picture No. M-1.

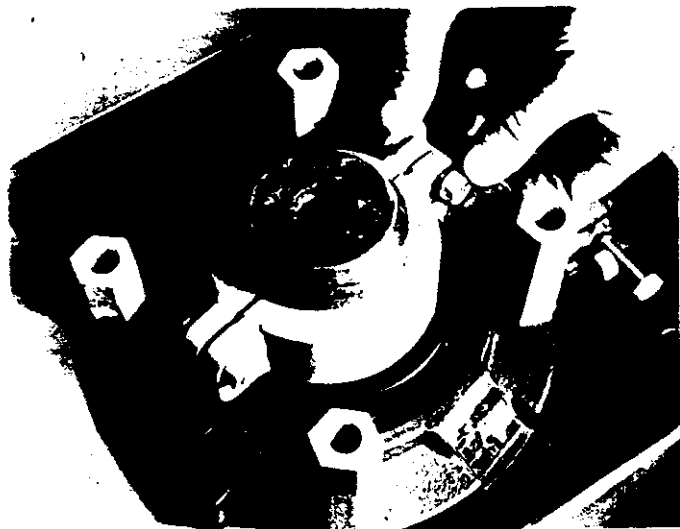
- RAISE UNIT POLE UP THROUGH PLATE (2), BEARING (A) AND HOLD IN POSITION.
- PLACE INNER SPLIT RING (5) (HALF WITH TWO HOLES IN IT) DOWN INTO TOP OF BEARING IN THE SPACE BETWEEN THE NO. (C) UNIT POLE AND THE INNER RACE OF THE BEARING - THE OUTER EDGE CLOSEST TO THE HOLES FACES UP! LINE UP THE HOLES IN THE SPLIT RING HALF WITH THE TWO SET SCREWS IN THE TOP FLANGE OF THE BEARING (SLIGHTLY RAISING OR LOWERING OF UNIT POLE MIGHT BE NEEDED FOR PROPER VERTICAL ALIGNMENT)
- ONCE IN LINE TURN TOP TWO SET SCREWS IN ENOUGH TO HOLD THIS RING HALF IN PLACE
- ~~~~ **DO NOT TIGHTEN SET SCREWS THROUGH TO UNIT POLE AT THIS TIME!**
- DROP REMAINING SPLIT RING (5) (HALF WITHOUT HOLES) DOWN INTO BEARING OPPOSITE THE ONE WITH HOLES.
- ~~~~ LEAVE SET SCREWS AS IS - CONTINUE TO HOLD UNIT POLE UP!
- ~~~~ GO TO FOLLOWING PAGE.

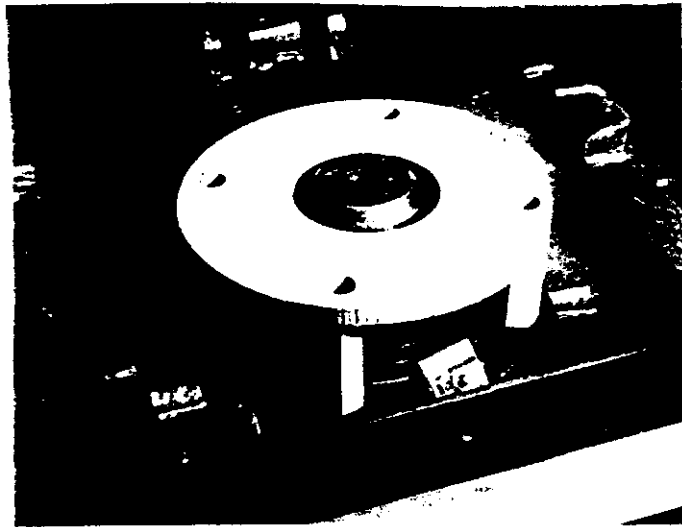
- PLACE THE TWO CLAMP W/LDMT. (6) HALVES AROUND UNIT POLE (C) BETWEEN TOP EDGE OF BEARING (A) AND THE UPPER LIP OF THE UNIT POLE.
- BOLT CLAMP HALVES TOGETHER USING (4) $\frac{3}{8}$ "-16 THD. x $1\frac{1}{2}$ " LONG HEX BOLTS AND $\frac{3}{8}$ "-16 THD. ESNA STOP NUTS - TIGHTEN SO THAT THE CLAMP HAS JUST ENOUGH PLAY IN IT THAT YOU CAN TURN IT BY HAND ON THE UNIT POLE.
- ~~~~~ AT THIS TIME YOU CAN LET THE UNIT POLE (C) DOWN TO HANG FREELY!
- TIGHTEN THE (4) $\frac{3}{8}$ " BOLTS HOLDING THE NO. (6) CLAMP HALVES THE REMAINDER OF THE WAY.
- TIGHTEN FOUR SET SCREWS (2 TOP - 2 BOTTOM) IN THE BEARING (A) (TORQUE TO 408 INCH POUNDS) ~ (34 FOOT POUNDS)

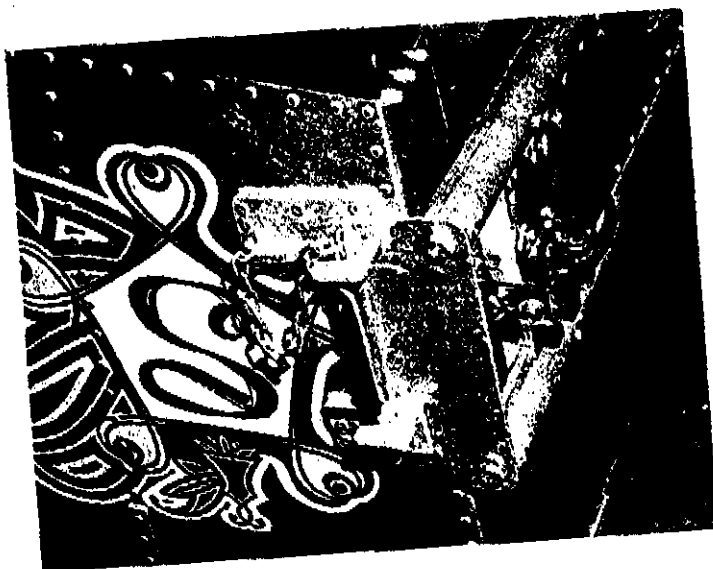
SECONDARY LATCHING DEVICE

for Seat Handlebar of
BIG ELI Scrambler ride.

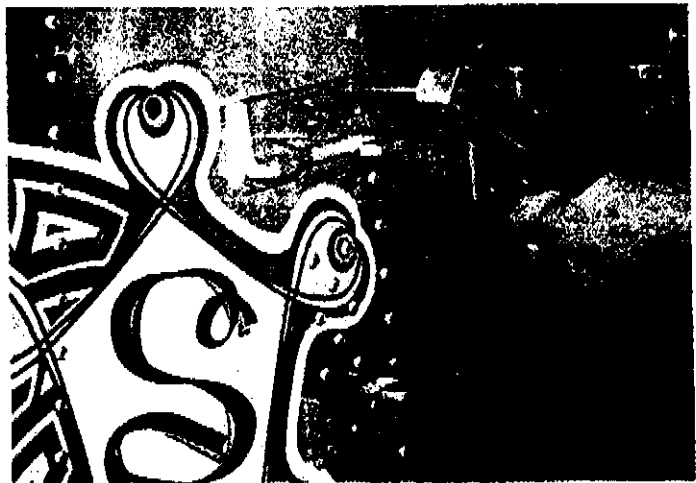
5

5. Remove the template and install the two brackets on the side of the seat. The top bracket is the long one, and the hook must be on the bottom side. On the bottom bracket the hook must be on the top side. The two holes located by the template for each bracket are for the top front and bottom rear rivet of each bracket. Set the two 5/32" rivets in each bracket. See Picture No. 5.

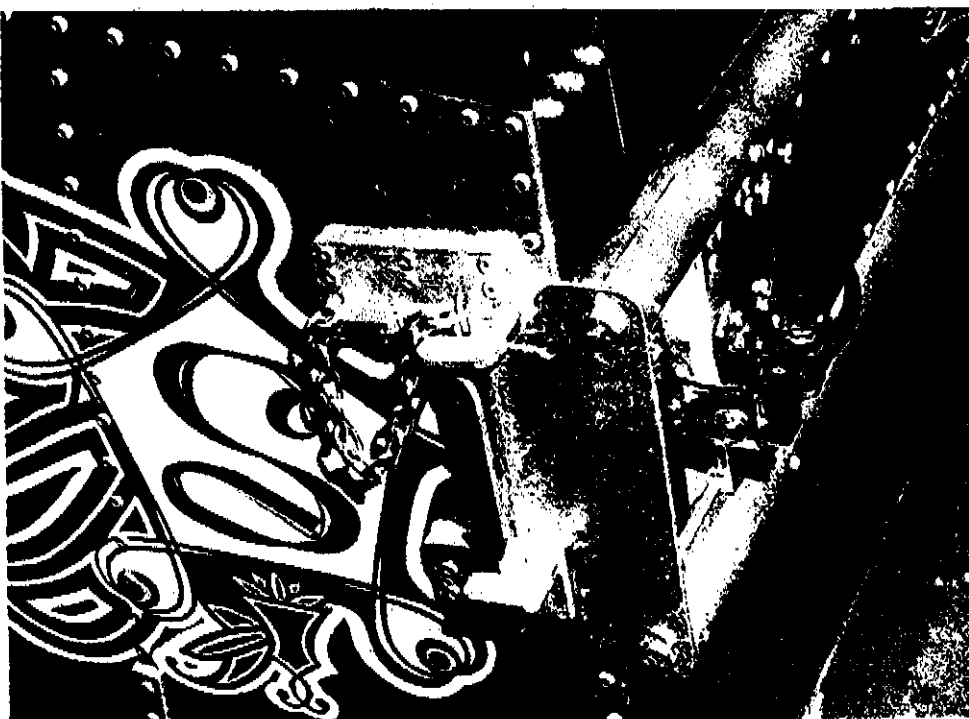
6. With a No. 20 drill, drill through the remaining four holes in the top bracket to locate matching holes in the seat skin, and then do the same with the three in the bottom bracket. Then install the 5/32" rivets.
7. Install the chain with the end link laid on top of the bracket and pointed straight out, away from the seat. The round head of the 10-24 screw (3/4" long) and the washer go on the top of the chain link, and the self-locking nut goes underneath the bracket.
8. Install the handlebar bracket on the end of the handlebar with the two 3/8"-16 hex head bolts, 1" long, and be sure there is an internal lockwasher under the head of each bolt.
9. The locking pin will drop in place freely if all parts have been installed correctly.
10. This completes the installation of the secondary latch, and it is shown in Picture No. 6.

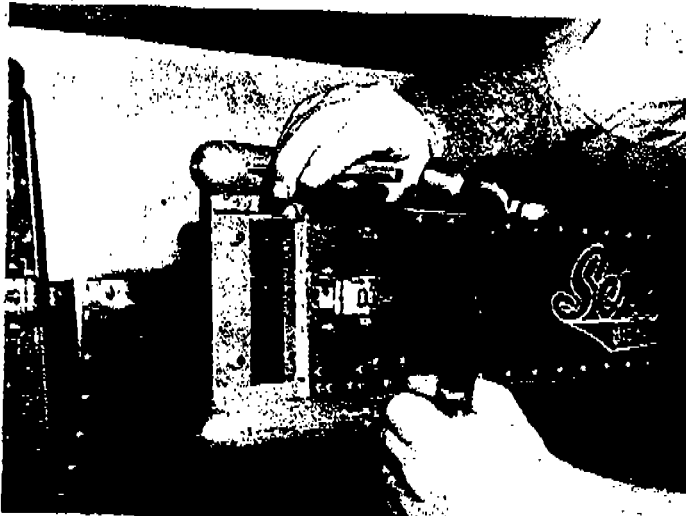
1

These instructions apply only to Scrambler seats equipped with aluminum handlebars.
