LOSS CONTROL BULLETIN

MFG: MANCO PRODUCTS, INC.
 NAME: ROUND UP - *FOLD*
 TYPE: NON-KIDDIE

EMERGENCY ALERT ON THE RIDE, "ROUND-UP"
 (by Manco, Hrubutz Mfg, or Kilinski Mfg)

In early June 1993, a Round-Up ride experienced a failure of a weld located on the shrink collar on the main center spindle (two drawings are attached for reference). This is the first known occasion for this style of shaft to fail since the manufacturer's Bulletin requiring replacement of an earlier system.

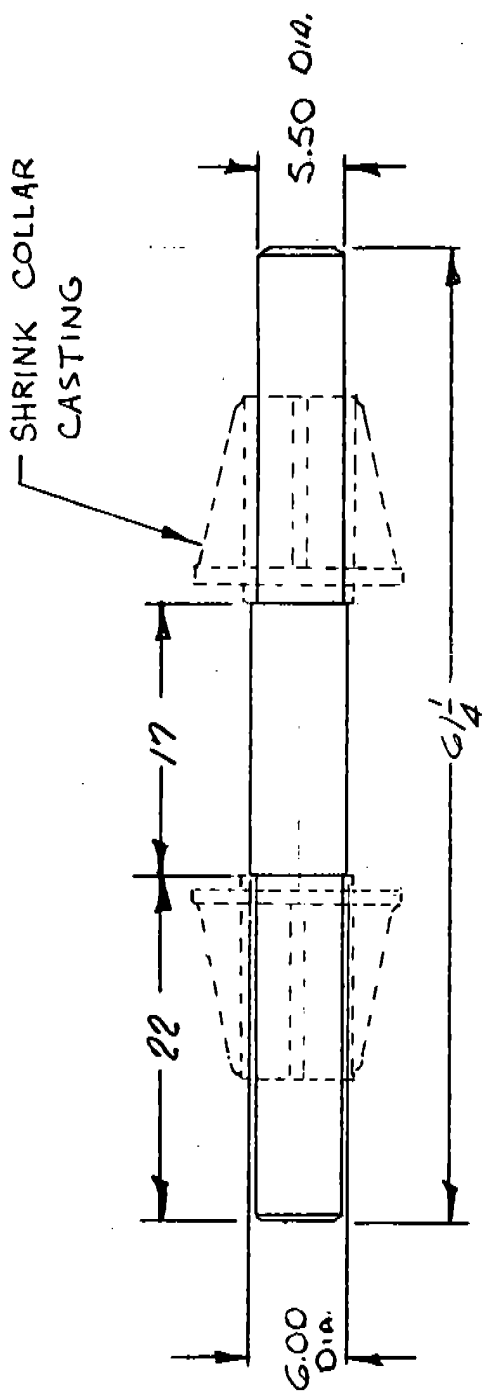
DATE 4-12-89
DRAWN BY M.D.Z.
SCALE
NO. SK-41285

REV	DATE	DESCRIPTION
A	3-17-89	SHOW SHRINK COLLARS

The weld should be visually inspected immediately and periodically thereafter.

In doing so, the power for the ride needs to be turned off, and the brush holder located at the end of the main boom removed. Once this is completed, the weld that ties the (1) shrink collar to the (2) steel plate needs to be cleaned and inspected. See the first of the drawings for areas marked (1) and (2). Should a visual indication be found, the ride needs to be closed and the K&K Insurance Group, Loss Control Division, notified immediately (219-455-5709).
