# Exact Corporative Supplying New and Innovative Equipment to

MFG: FABBRI, s.r.l. NAME: CRAZY DANCE TYPE: NON-KIDDIE

## SERVICE BULLETIN

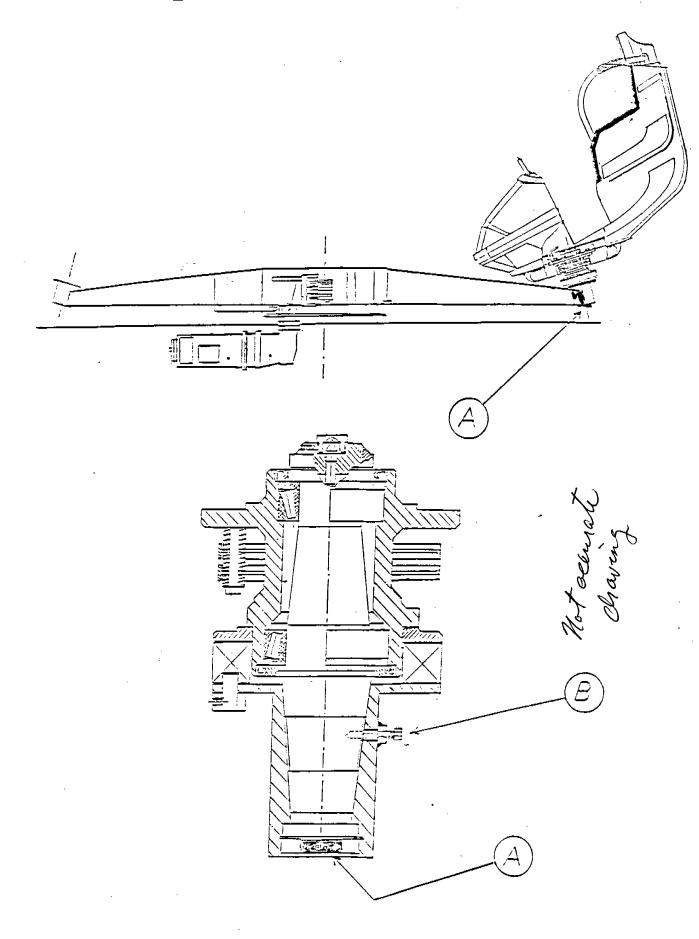
RIDE:	DE: CRAZY DANCE		DECEMBER 10, 1990							
SUBJECT:	VEHICLE SPINDLE BOLTS	BULLET	TIN NUMBER:	FC001						
It has b vehicle loosen compo	een determined through investige tapered spindle into its socket of over a period of time. The nents and maintenance characturer, FarFabbri, s.r.l.	ation that n the end following	the bolts used of the satellite modification.	to lock the sweep can change in						
1	. Existing bolts x lock washers	s (24 mm	x 80 mm x ars	ada 8 8) ara

- 1. Existing bolts x lock washers (24 mm x 80 mm x grade 8.8) are to be replaced with 24 mm x 80 mm x grade 10.9 and torqued in place to 700 nm (515 ft. lbs) (refer to Figure A).
- 2. Install tapered spindle lock bolts (refer to Figure B).
- 3. Change maintenance procedure to include checking the torque of the bolts on a monthly basis.
- 4. Replace bolts on an annual basis.

Kits are available for lock bolt and replacement bolts free of charge and can be ordered through Exsaco Corporation, One North Santa Fe Street, Alvarado, Texas 76009, 817-783-2265.

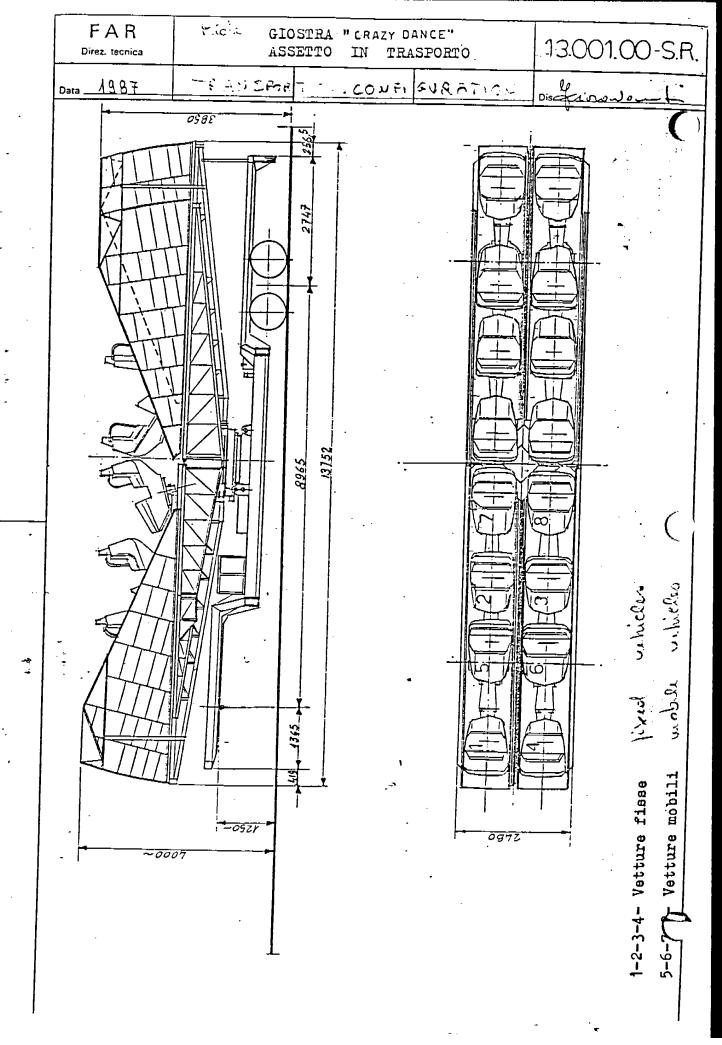
Dis. 13.101.00 SR Dis. 13.103.00 ST. 83-45x260 ST. 82 / ST. 75 Dis. 6.105.00

It consists of a truck where the amusement ride is installed and it is the place where the hydraulic, pneumatic, and electric equipment, installations are laid. It's structure is designed so that it can hold with a large security all the static and dynamic stress of the ride in movement. It is placed on the ground not only with the wheels of the truck but also with the hydraulic levelling jack, with appropriate outriggers with screw jacks.

Construction material Front and Back Neck Crossbar for legs Legs Rotating Center Frame

FE 37 Beam 300B Beam HEA 200 FE 37 Tube R. 300x200x10 Tubular FE 37 Tube Q 200 x 10

- 1. Truck Frame
- 2. Back Train
- 3. Hydraulic Jacks
- 4. Screw Jacks
- 5. Underpinning Legs
- 6. Frame for Rotating Center

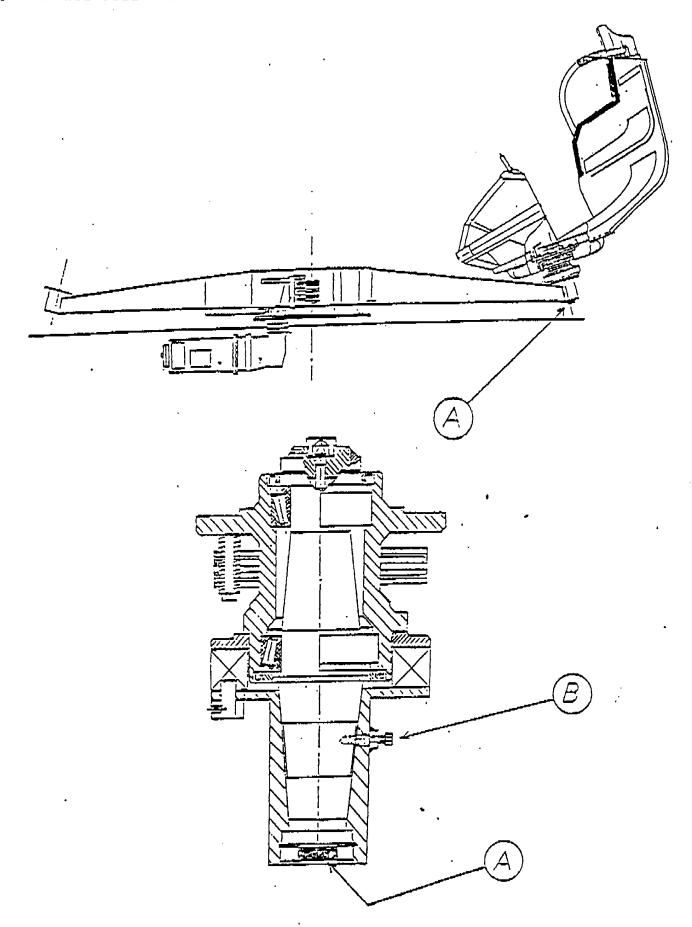
It has been determined through investigation that the bolts used to lock the vehicle tapered spindle into its socket on the end of the satellite sweep can loosen over a period of time. The following modification, change in components and maintenance change are now required by the manufacturer, FarFabbri, s.r.l.

It has been determined by FarFabbri, s.r.l. of the necessity to inspect and test by approved non-destructive testing procedures the sweep hooks and welding located in the inside end of the detachable vehicle sweeps (refer to Point A). This inspection must be done on an annual basis. If cracks are detected, consult the factory for proper repair procedures.

- 1. Existing bolts x lock washers (24 mm x 80 mm x grade 8.8) are to be replaced with 24 mm x 80 mm x grade 10.9 and torqued in place to 700 nm (515 ft. lbs) (refer to Figure A).
- 2. Install tapered spindle lock bolts (refer to Figure B).
- 3. Change maintenance procedure to include checking the torque of the bolts on a monthly basis.
- Replace bolts on an annual basis.

- 1. FarFabbri, s.r.l. requires that all spindle bolts be replaced on an annual basis.
- 2. Use only grade 10.9 bolts.
- 3. Your monthly maintenance procedure should include checking the torque of these bolts. Refer to the following chart for recommended torque values pertaining to your equipment.
- 4. All rides should have a factory installed spindle safety bolt (Figure B). If you do not, contact Exsaco Corporation immediately at 1-800-545-0667 or 817-783-2265.

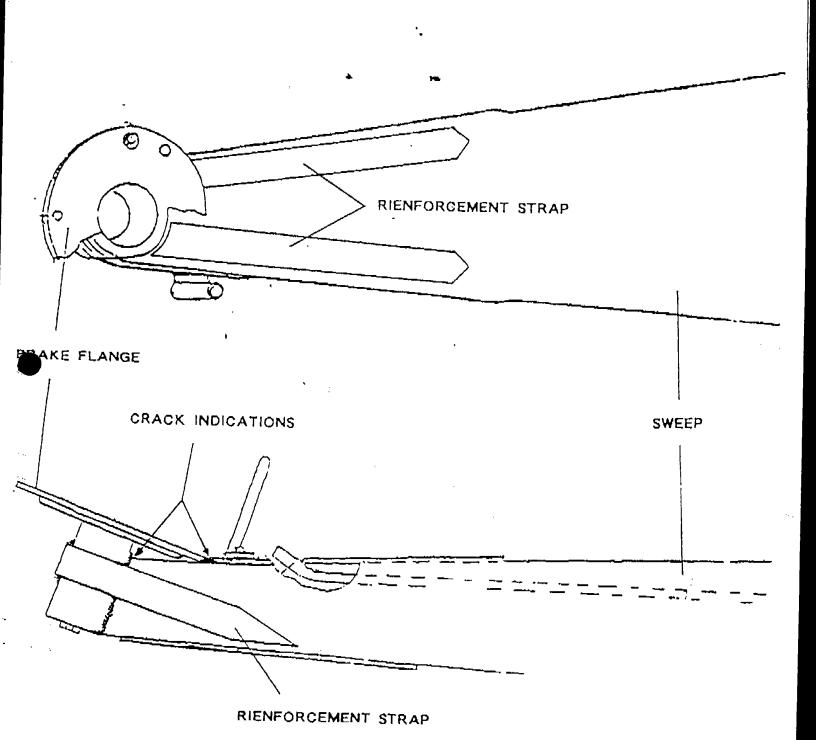
An incident occurred where the car spindle case separated from the sweep. This incident was directly related to an insufficient weld application. Through futher inspections of the remaining rides, it was determined to be an isolated case. Refer to Drawing A for the location of possible cracks.

In the meantime, you are required to visually inspect the suspect area each day before opening the ride to the public. If any cracks are detected, contact Exsaco Corporation at 1-800-545-0667 or 817-783-2265 immediately.

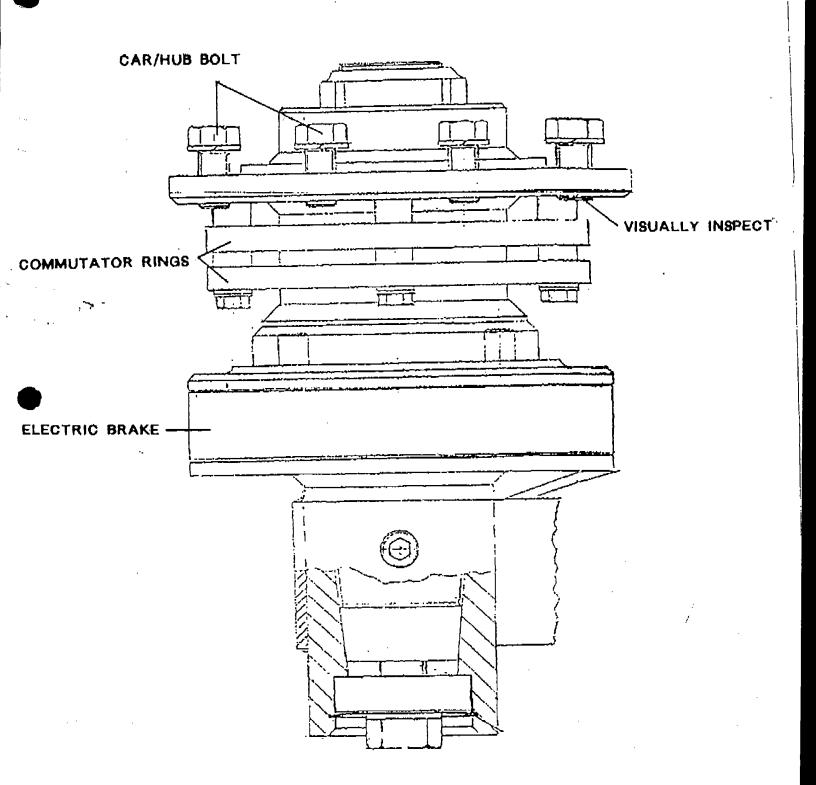
An incident occurred where the car/hub bolts vibrated loose even though lock washers were in place. This allowed the car flange to move and deform the threads in the hub. Eventually, all the bolts stripped out and the car landed on the platform. Luckily, no one was injured.

Bolt Size	<u>Status</u>	<u>Torque</u>
16mm x 30, grade 8.8	Original Bolt	150 ft. lbs.
18mm x 30, grade 8.8	Replacement Bolt	190 ft, lbs.
